WATERFORD PLACE HOMEOWNERS ASSOCIATION, INC.

Reality Check: The results of “keeping HOA assessments low.”

**CONDITION OF THE WATERFORD PLACE HOMEOWNERS ASSOCIATION COMMON ELEMENTS
(MARCH 2020)**

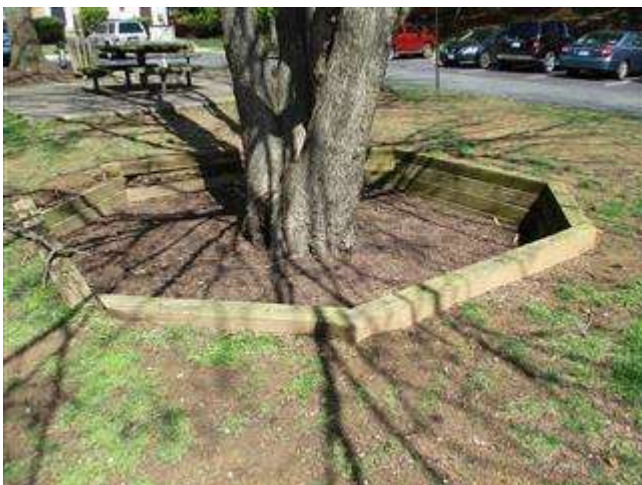
17 Tree Well/Planter (rotted wood, exposed rebar/steel bars) (March 2020)

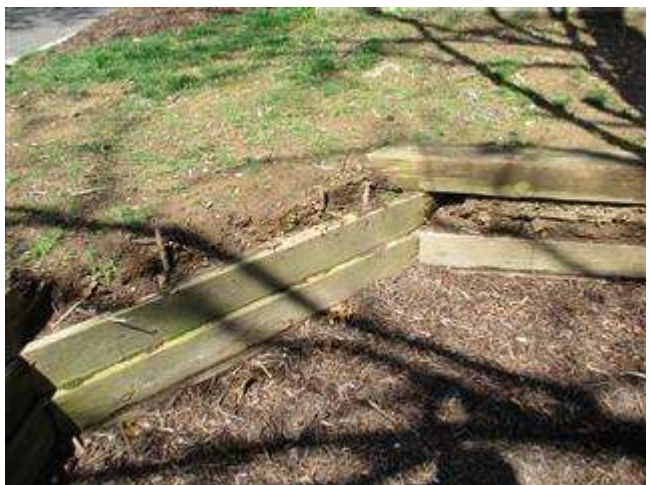
18 Tree Well/Planter (rotted wood, exposed rebar/steel bars) (March 2020)

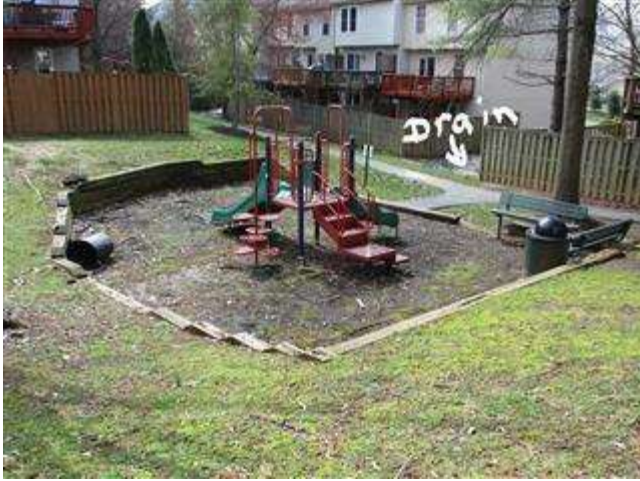
19 Tot Lot (Installed in 2005; 15 years old; non-compliant due to lack of maintenance) (March 2020)

Most industry experts estimate the average lifespan of playground equipment to be around 10 to 15 years.

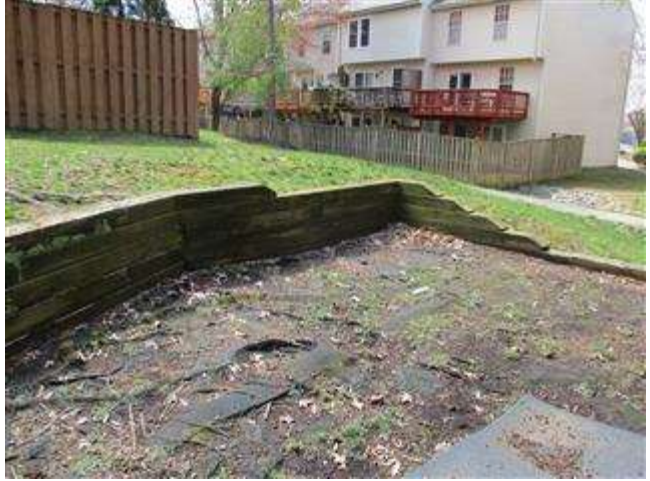
20 Tot Lot (Installed in 2005; 15 years old; non-compliant due to lack of maintenance) (March 2020)

Most industry experts estimate the average lifespan of playground equipment to be around 10 to 15 years.

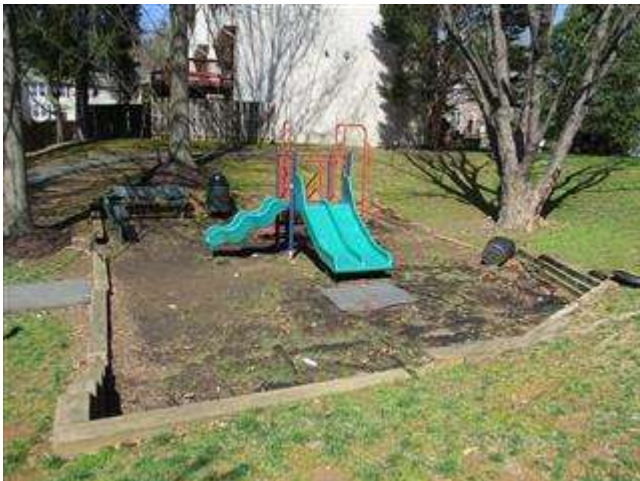
21 Tot Lot (Installed in 2005; 15 years old; non-compliant due to lack of maintenance) (March 2020)

Most industry experts estimate the average lifespan of playground equipment to be around 10 to 15 years.

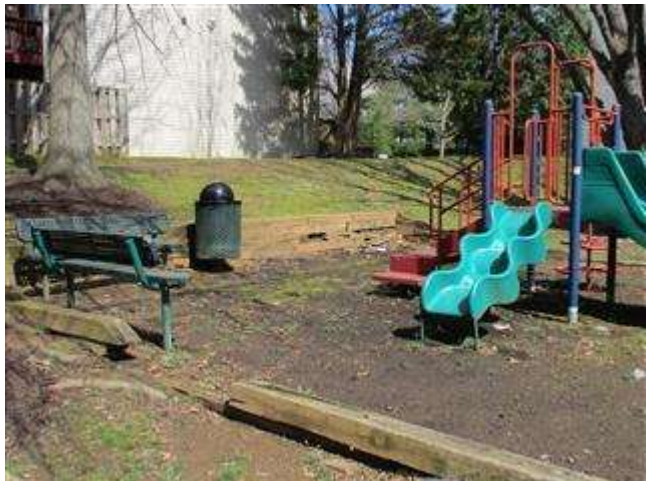
22 Tot Lot (Installed in 2005; 15 years old; non-compliant due to lack of maintenance) (March 2020)

Most industry experts estimate the average lifespan of playground equipment to be around 10 to 15 years.

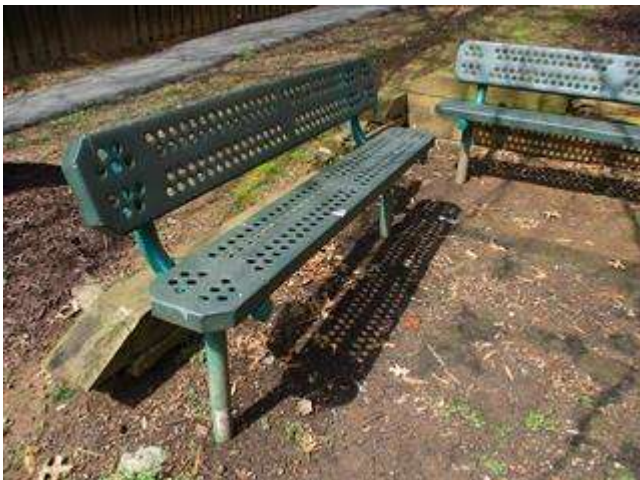
23 Tot Lot (Installed in 2005; 15 years old; non-compliant due to lack of maintenance) (March 2020)

Most industry experts estimate the average lifespan of playground equipment to be around 10 to 15 years.

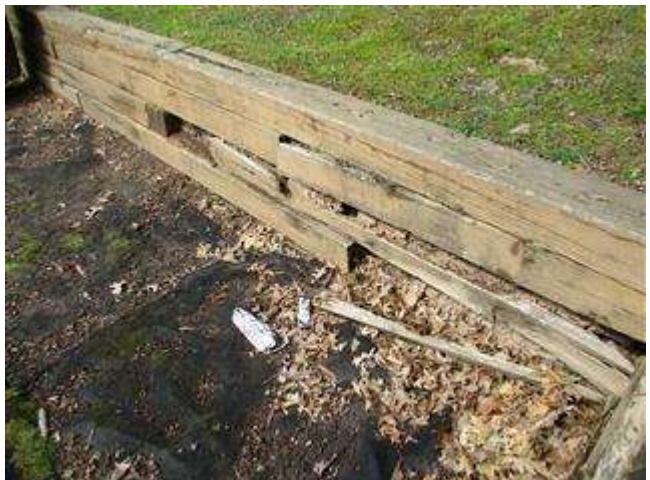
24 Tot Lot (Installed in 2005; 15 years old; non-compliant due to lack of maintenance) (March 2020)

Most industry experts estimate the average lifespan of playground equipment to be around 10 to 15 years.

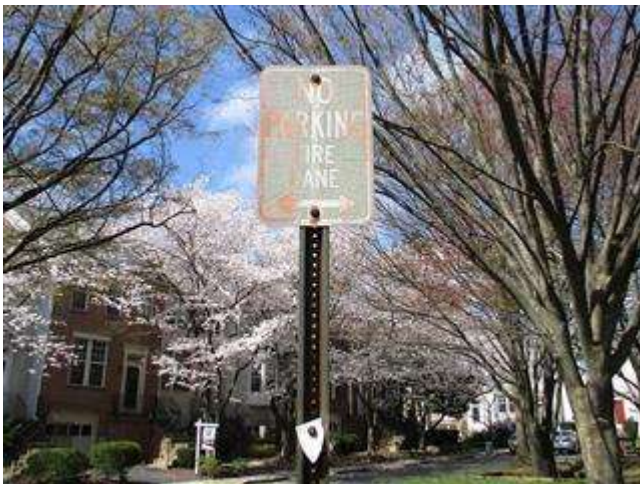
29 Signage (faded, unreadable) (March 2020)

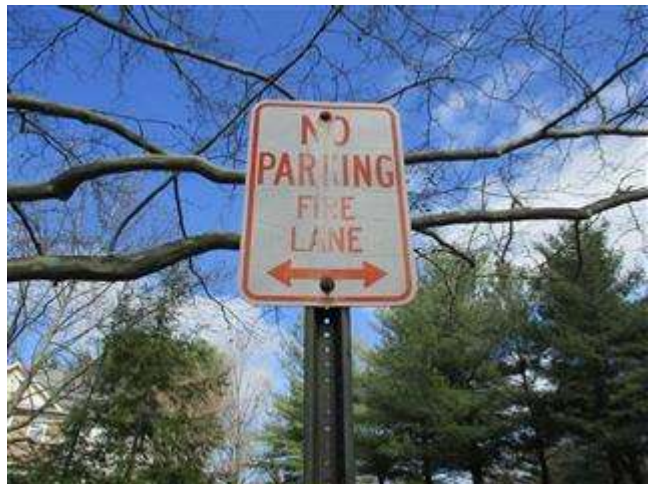
30 Signage (faded) (March 2020)
